Saturn Helium Bottles

Contract NAS 8-11555

Report on Problems Associated
with Heat Treatment

ER 13796

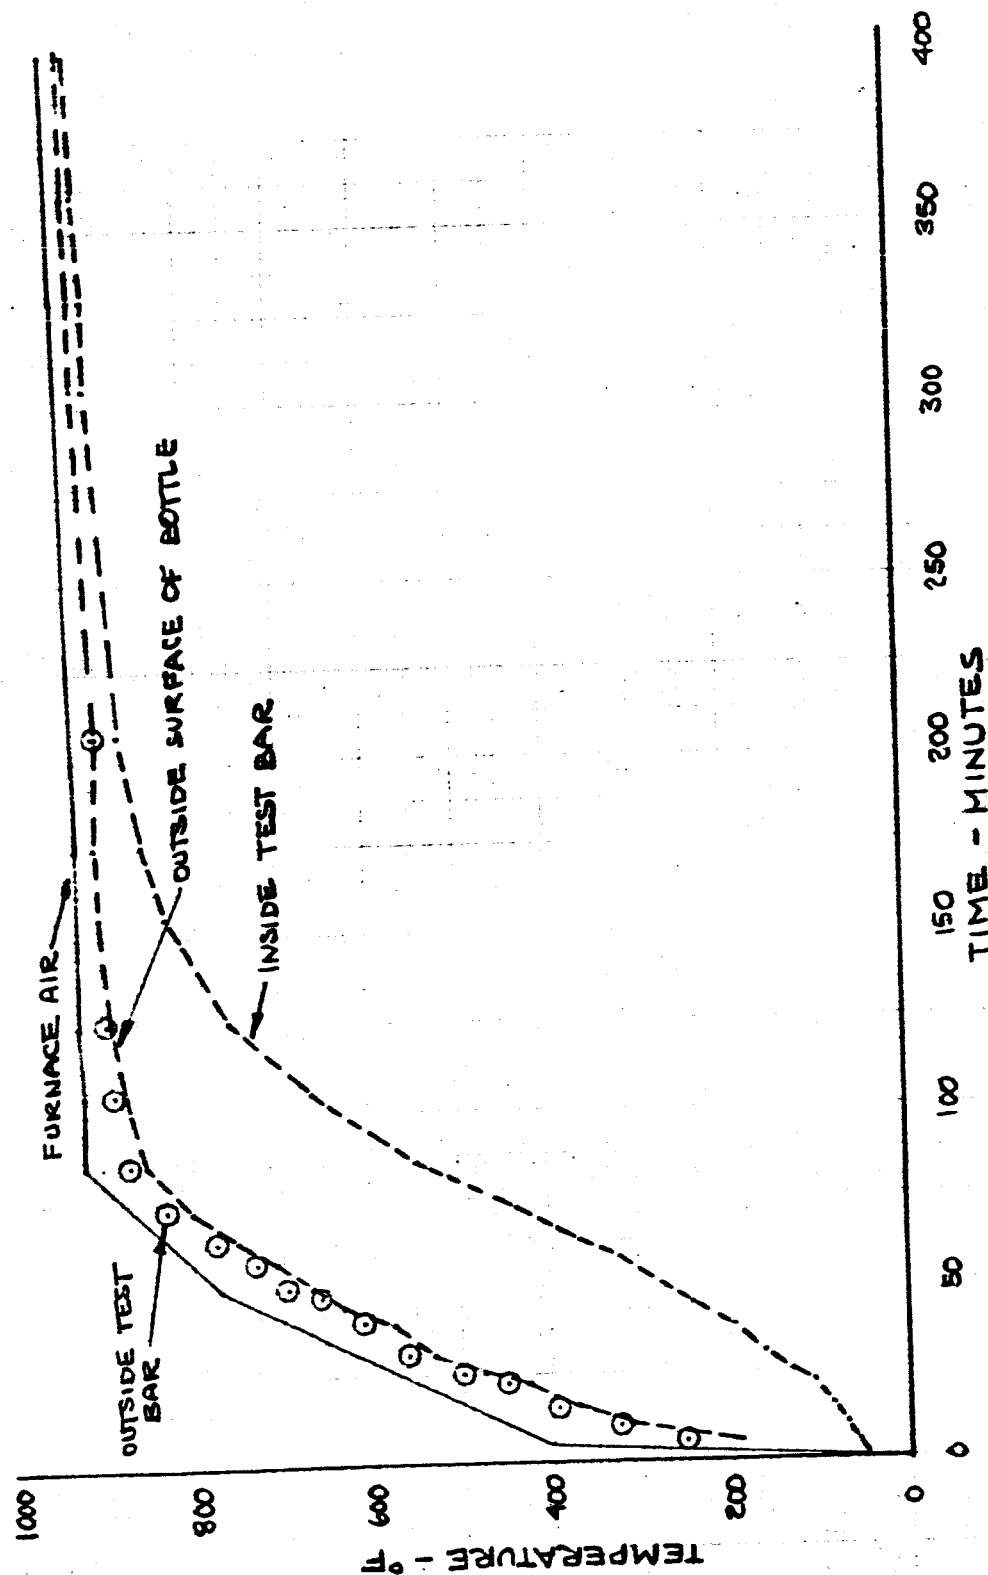
FIG. 1 : TEMPERATURE-TIME HISTORY (COLD FURNACE START)

A set of temperature data, illustrating the above, is shown in Fig. 1. For this run the furnace was brought up from room temperature with the bottle in the work zone. It can be seen that the outside test bar temperature leads the outside bottle surface temperature for about 150 minutes. The inside test bar temperature lags the outside bottle surface temperature for more than 200 minutes. A second set of data is presented in Fig. 2 for the case where the furnace was preheated to 945°F and then the load was inserted. From this figure, the same lead and lag trend can be seen but several important differences are noteworthy. First, the outside test bar temperature lead over the bottle is more pronounced. Second, the lag between the furnace air temperature and the outside test bar temperature is essentially zero after 30 minutes. Further study of Figs. 1 and 2 shows that in either case, the bottle surface temperature is about the same at 100 minutes. From this point on, the time it takes to bring the bottle wall into the desired range (935 ± 10°F) depends entirely on the furnace operator. In the run shown in Fig. 1, the controller set points were reduced at 125 minutes and increased at 175 minutes. As a result, the 30 minute hold period did not start until 436 minutes. In the run depicted in Fig. 2 the operator was urged to be less cautious. The controller was initially set at 960°F, at about 80 minutes it was reduced to 940°F and at about 130 minutes it was increased to 950°F. The result in this case was that the hold period started at 210 minutes.

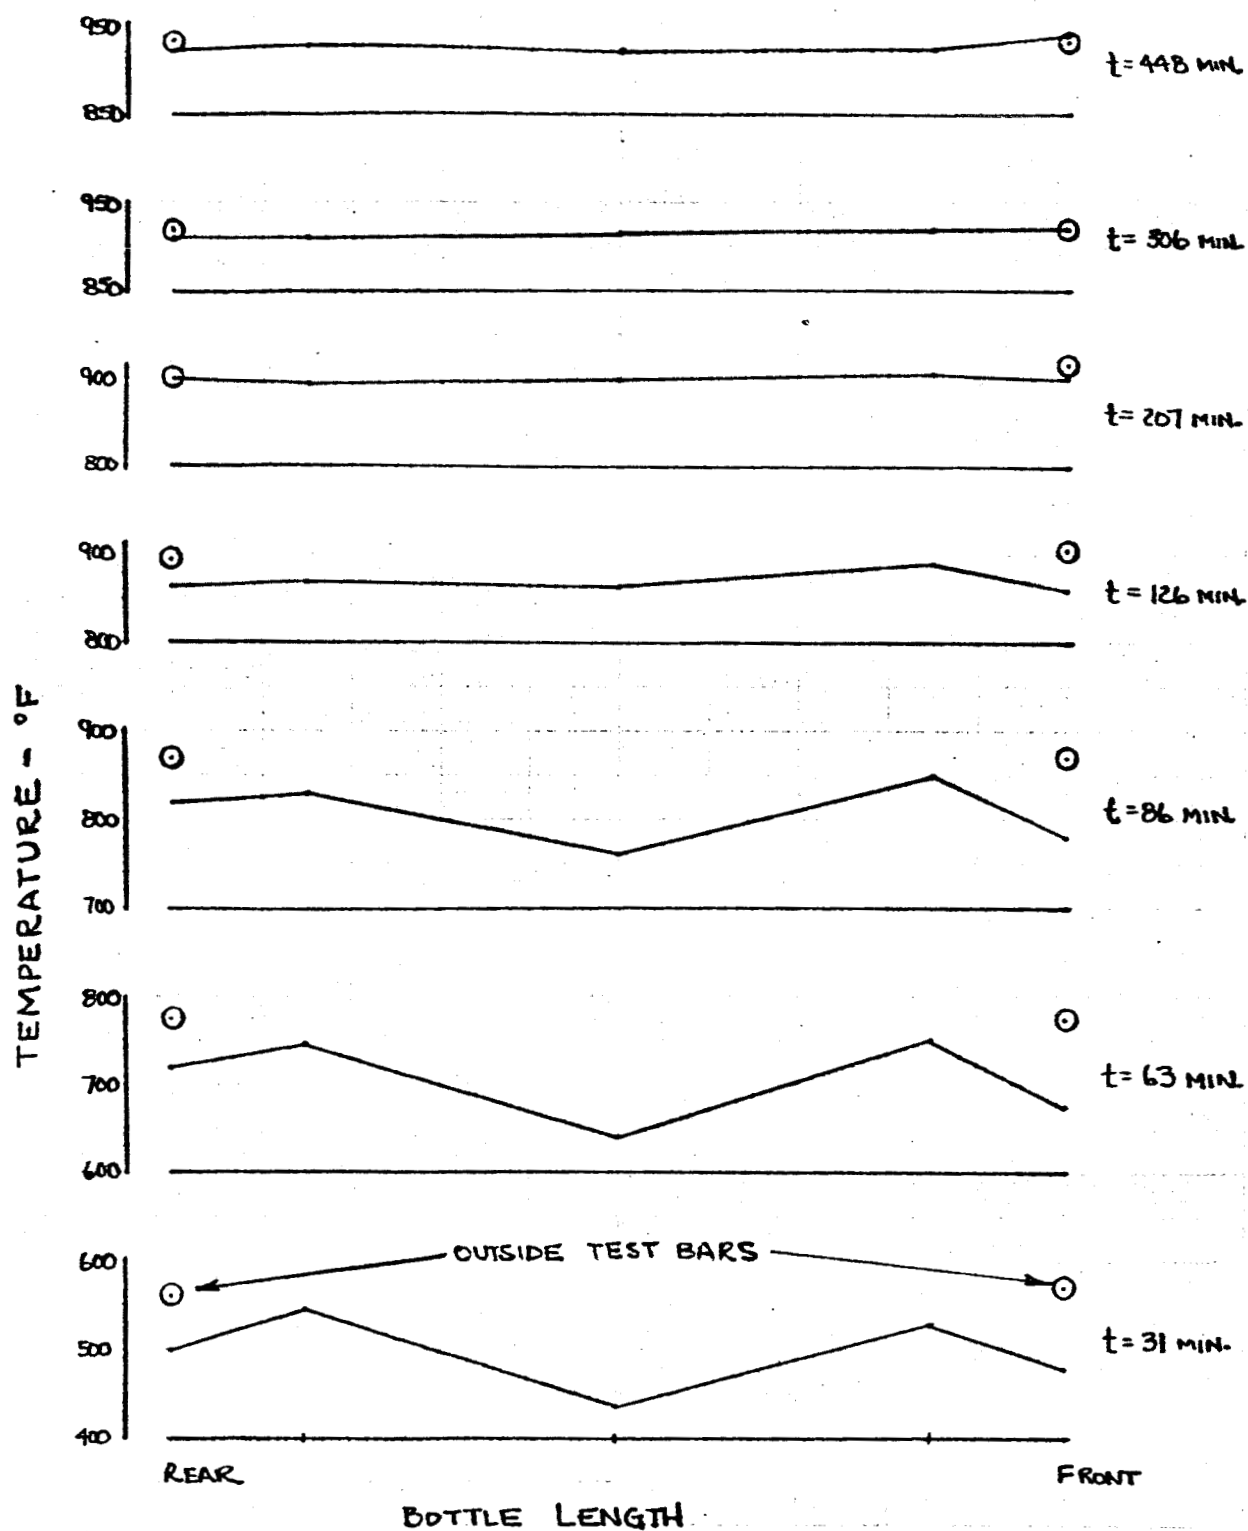
FIG. 3 : BOTTLE TEMPERATURE DISTRIBUTION
(STARTING WITH COLD FURNACE)

Additional data is presented in Figs. 3 and 4 which shows how the temperature varies along the length of the bottle at various instants of time. A study of these figures will show that, in both cases, when the bottle reaches 900°F, the temperature is essentially uniform along its length. Note, however, in Fig. 4, the outside test bars are at 900°F after 46 minutes while the bottle is only about 800°F. In Fig. 3, for the cold furnace start, the test bars reach 900°F in about 126 minutes and the bottle is lagging only about 40°F.

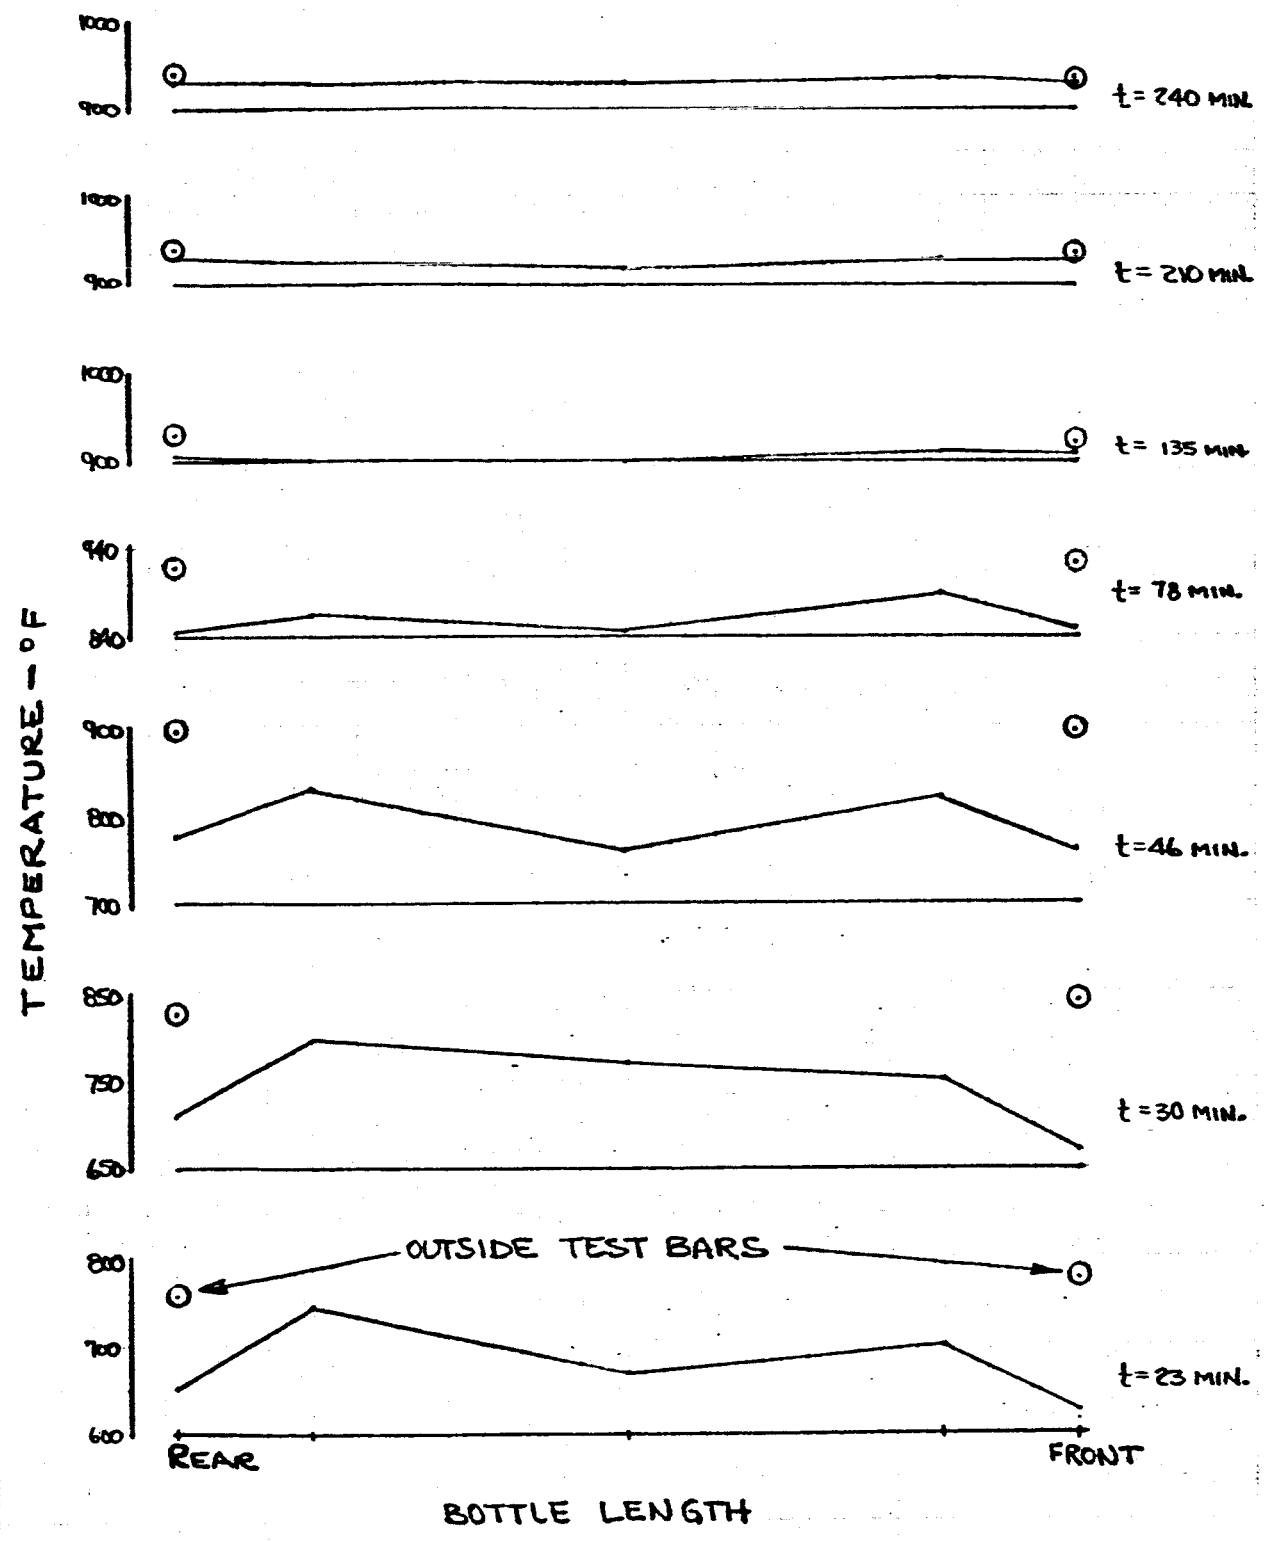
FIG. 4: BOTTLE TEMPERATURE DISTRIBUTION
(STARTING WITH HOT FURNACE)

1. No metallographic evidence in material from the bottle ends.
2. No temperatures above 945°F at three locations along the cylindrical portion of the bottle.
3. No significant difference between the temperatures at the ends of bottle as compared with the cylindrical portion for temperatures above 900°F (Fig. 4).

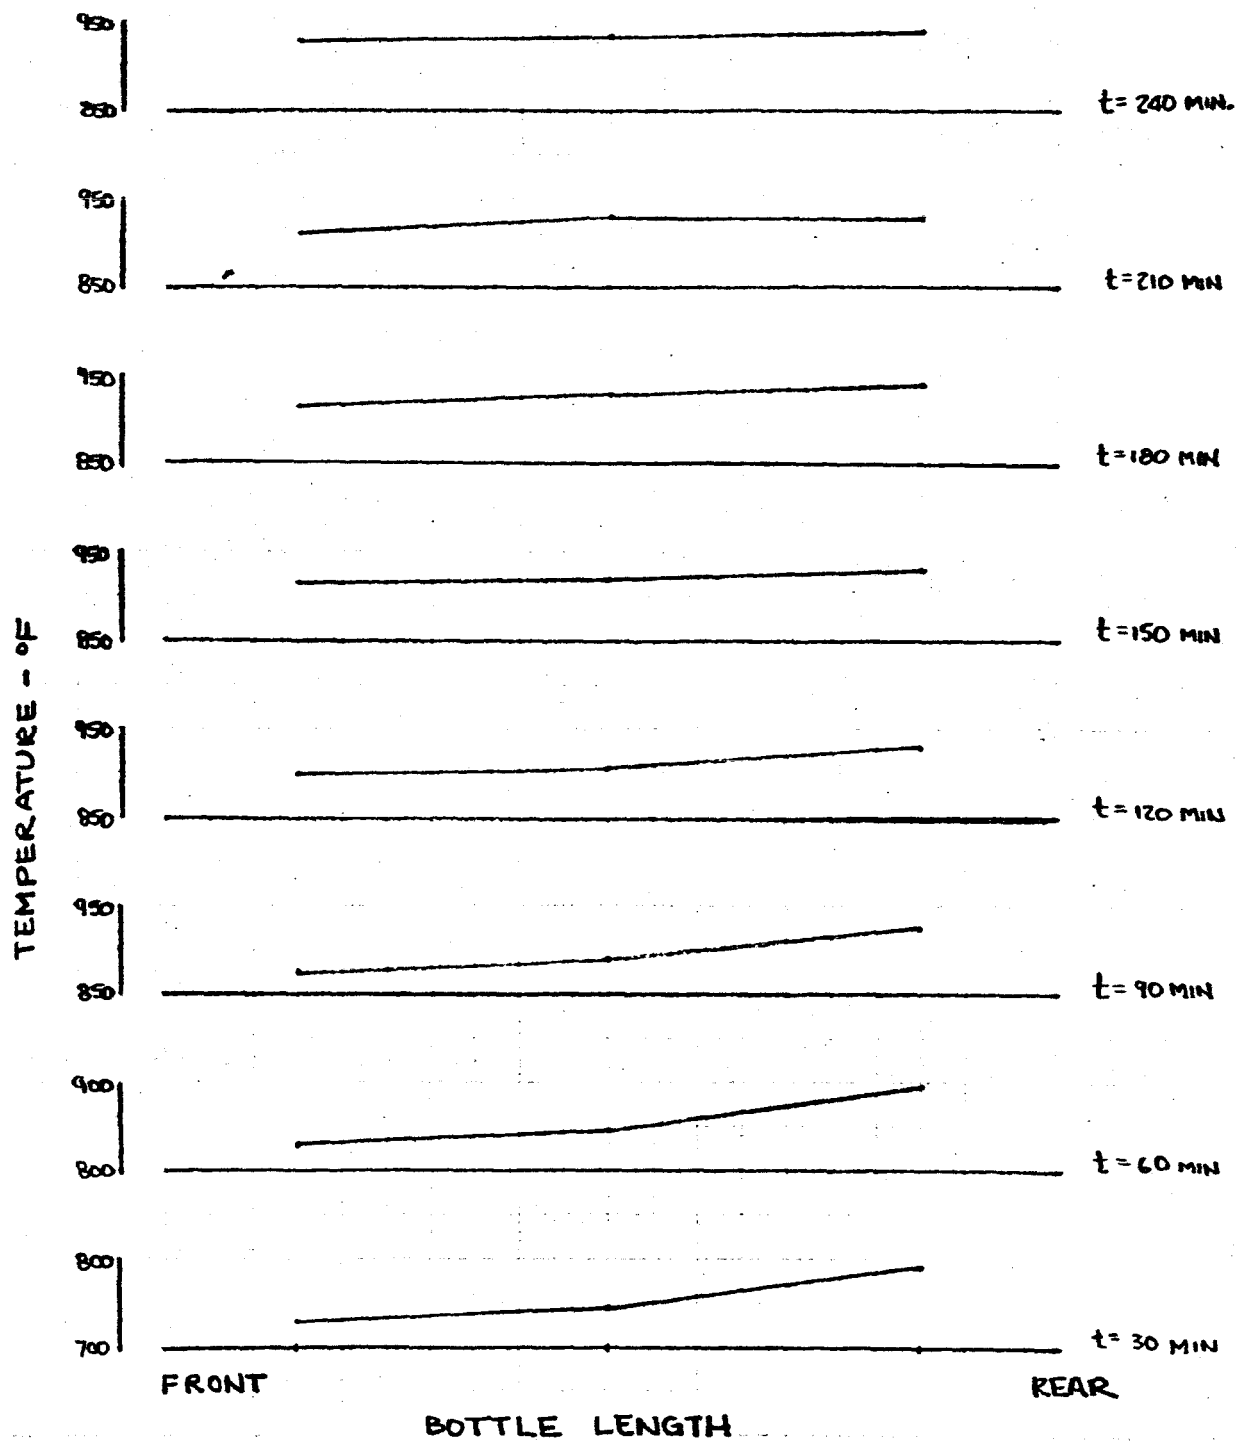
FIG. 7: BOTTLE TEMPERATURE DISTRIBUTION

As stated in the Introduction, the last five units to be heat treated were charged into a hot furnace and subsequently three units (S/N 0023, 0025, 0026) were placed in a rejected status because the test bar elongation values were below the minimum specified (see Table I). During heat treatment these units had the same three external surface thermocouples as did the previous units. It was immediately suspected that the test bars had been overheated. The temperature charts did not indicate any overheating of the bottles. Each test bar that had a low elongation value was examined metallographically and it was verified that they had been overheated. At the same time, samples were removed from either end of all three bottles and these micrographs showed no evidence of overheating. All of these photomicrographs are presented herein as Appendix A. Figures 6 to 11 show the Temperature-Time Histories and Temperature Distributions for these three units. If these figures are compared with Figs. 2 and 4, it will be seen that these units were heated at a significantly higher rate than the test unit of Fig. 2. This means that, initially, the controller set points must have been higher than the test run, probably 960-970°F. Unfortunately, no permanent records exist as to the actual settings for the processing of these units. It is concluded, however, that during the early part of the cycle (0-100 minutes), the furnace air was as high as 960-970°F and from Fig. 2, the test bars reached the same range. The bottles, however, never exceeded 945°F. The evidence that the bottles were not overheated consists of the following:

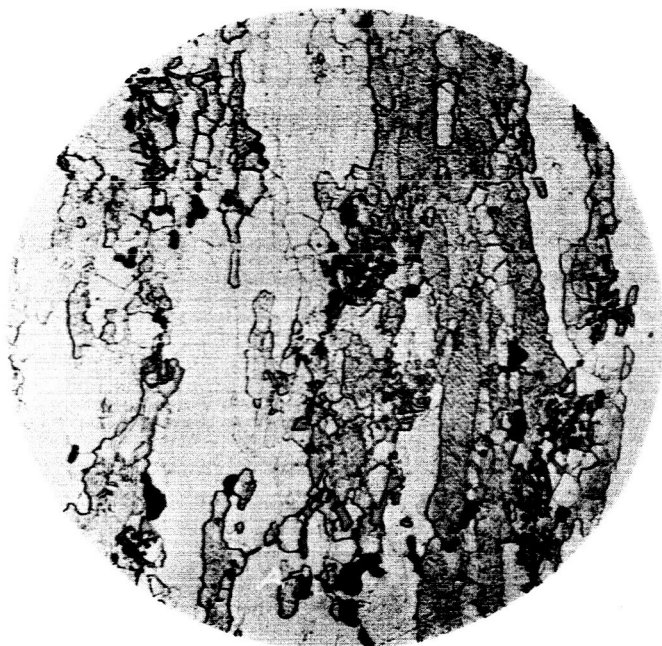
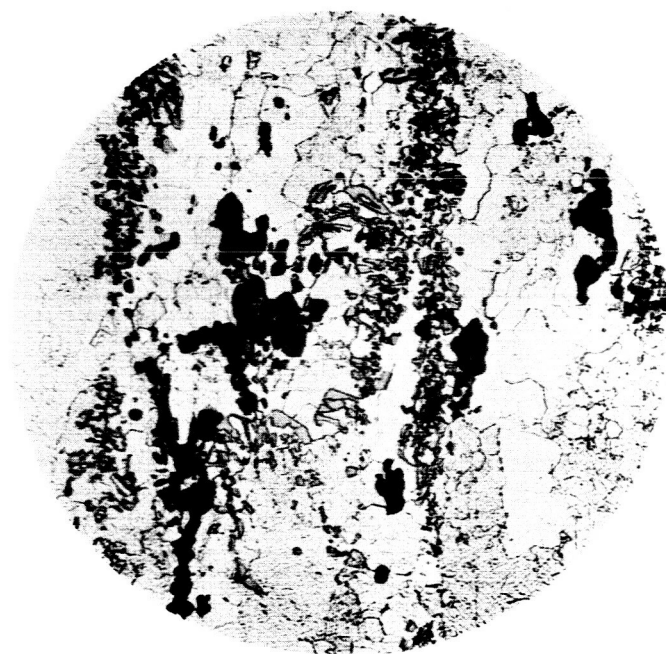
ML 118080
Etchant:
Keller's

Photomicrograph of 2014-T651 Aluminum Alloy Extrusion,
S/N 0075, showing typical metallographic structure of
material in as received condition.

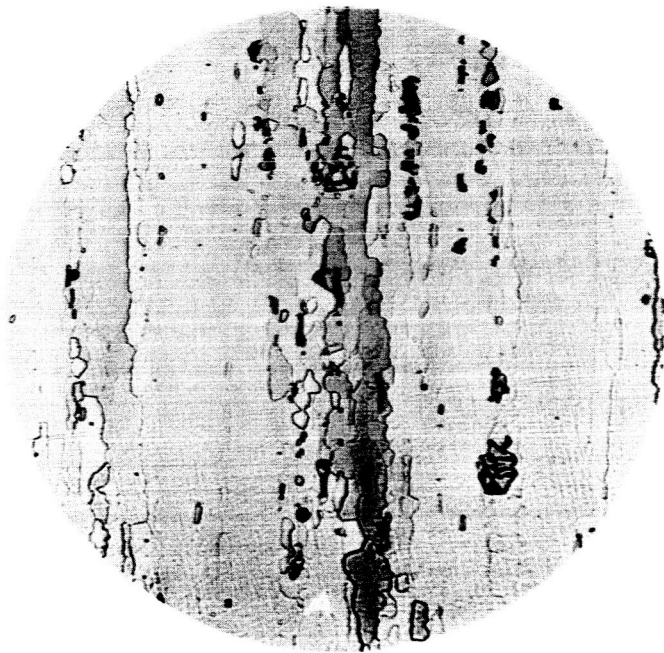
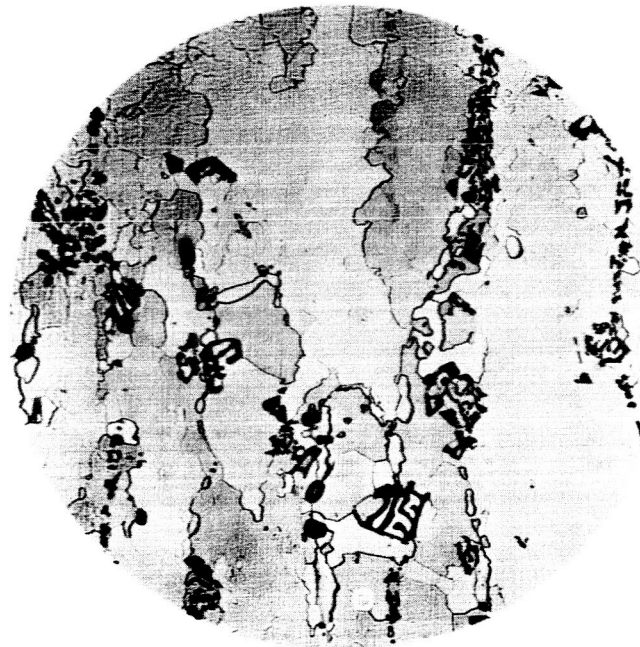
ML 118100
Etchant:
Keller's

Photomicrograph of 2014-T6 Aluminum Alloy Extrusion,
S/N 0035, showing satisfactory metallographic structure
of material after solution heat treatment at 945°F/30
minutes soak, cold water quench, and aged at 320°F for
20 hours.

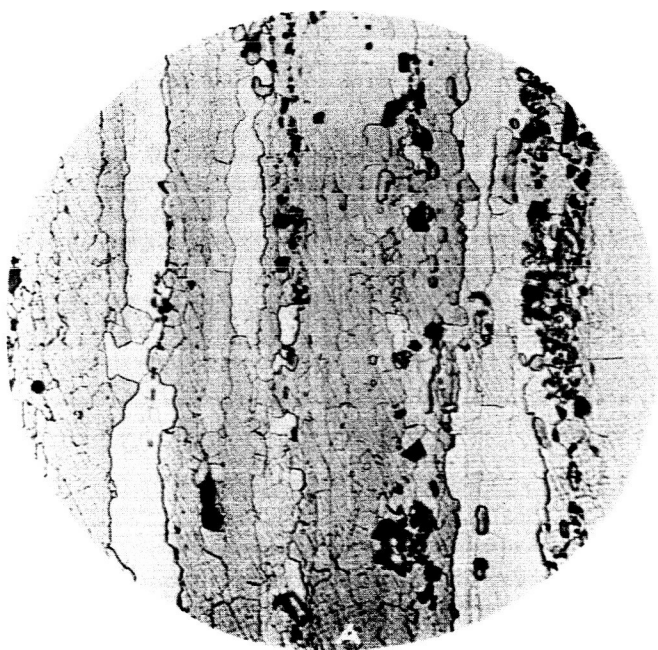
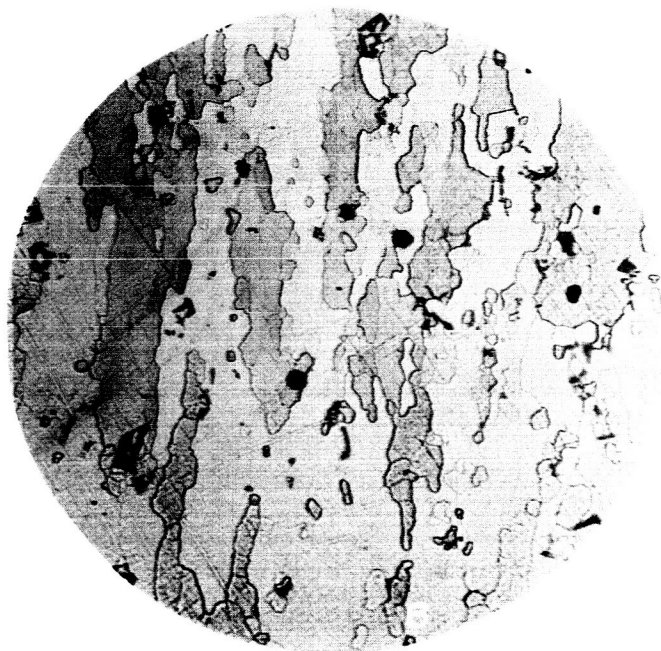
ML 118120
Etchant:
Keller's

Photomicrograph of 2014-T6 Aluminum Alloy Extrusion,
S/N 0035, showing typical metallographic structure of
material after solution heat treatment at 950°F/30
minutes soak, cold water quench, and aged at 320°F
for 20 hours.
